Investigation of metallic contaminations found
in vector- and mRNA-based
COVID-19-”vaccines”
- Preliminary results -

March 2022

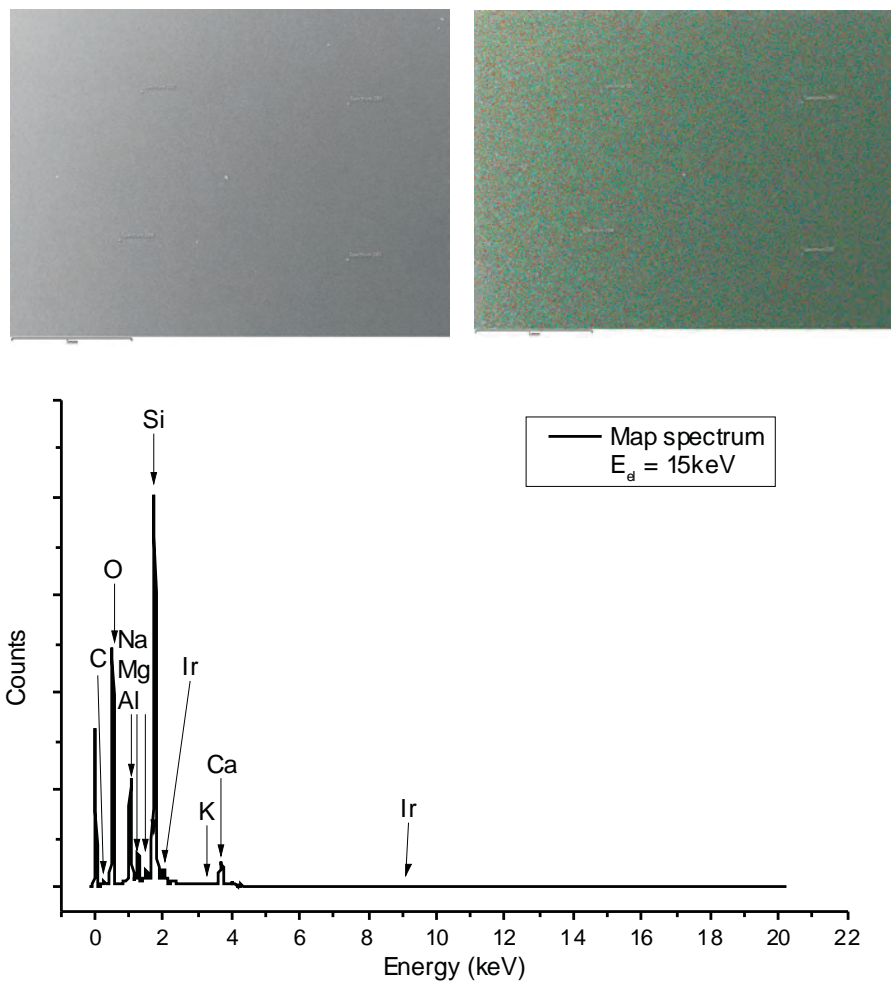
Figure 1 shows a SEM image of several mm^2 area of an empty microscope slide taken directly from the original packaging. The slide was covered with a thin film of Ir to ensure electrical conductivity directly before measurement. The slide is homogenous with a few microscopic scratches. The EDX-map indicates also a homogenous distribution of the chemical elements identified in the EDX-spectrum, i.e. Na), Mg, Al, K, Ca, and the main component is Si (likely SiO_2).

Figure 1: Top left: SEM image of an empty microscope slide. Top right: EDX map. Bottom: EDX sum spectrum of the mapped area.

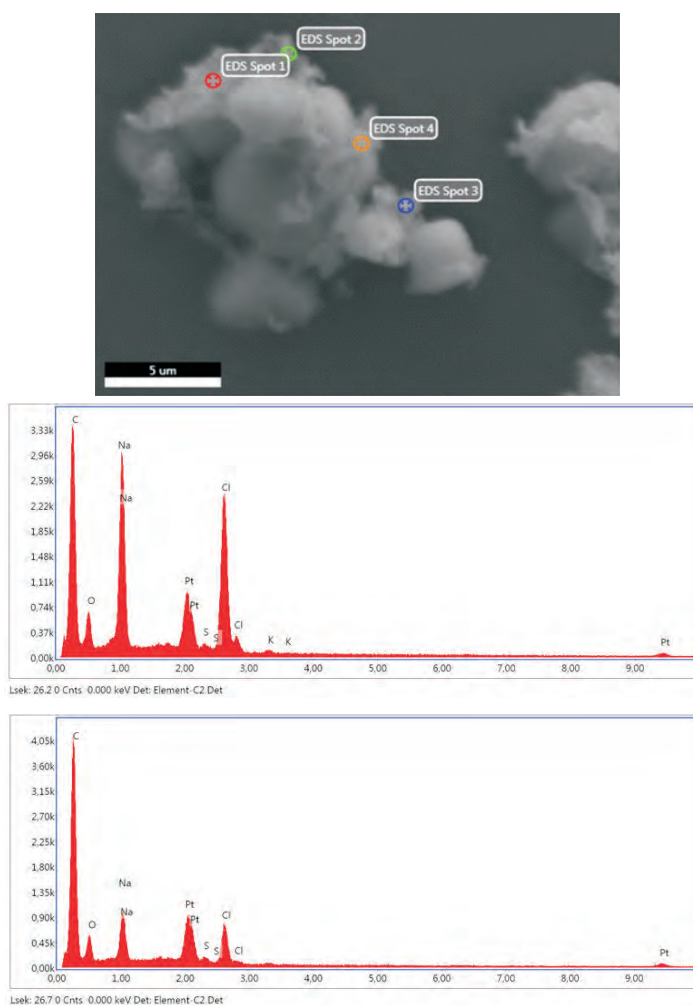
This sample was prepared in another lab for SEM/EDX-experiments. In this case the sample holder was covered with a thin platinum (Pt) film prior to the SEM/EDX measurements to ensure the required electrical conductivity. Figure 2 displays a typical SEM image of the protein component of Lubecavax. The EDX-point spectra show a spot with more Na and chlorine (Cl) (likely NaCl) (spot1) and a spot with more organic components (spot4), Except low amounts of S and K no other contaminations are found.

Figure 2: Top: SEM image of the dried protein component of Lubecavax-vaccine. Center and bottom: EDX point spectra of dried vaccine (spots 1 and 4). Note that Pt does not belong to the sample probed by EDX due to the sample preparation described above.

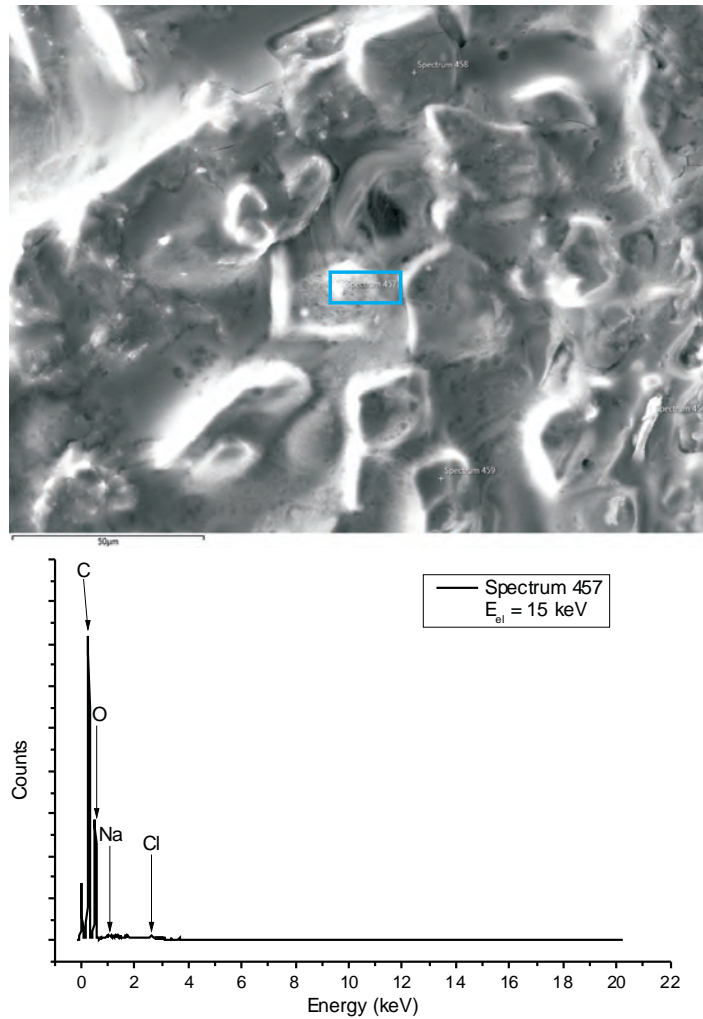
This sample was prepared via a syringe on a gold covered microscope slide as described in section 2. The EDX-spectrum shown in Fig.3 is typical for the dried Vaxzevria-”vaccine”, it consists of some Na und Cl (likely NaCl) and mainly of organic ingredients.

Figure 3: Top: SEM image of dried vaccine. Bottom: EDX point spectrum of dried vaccine (site 457), marked by a blue frame.

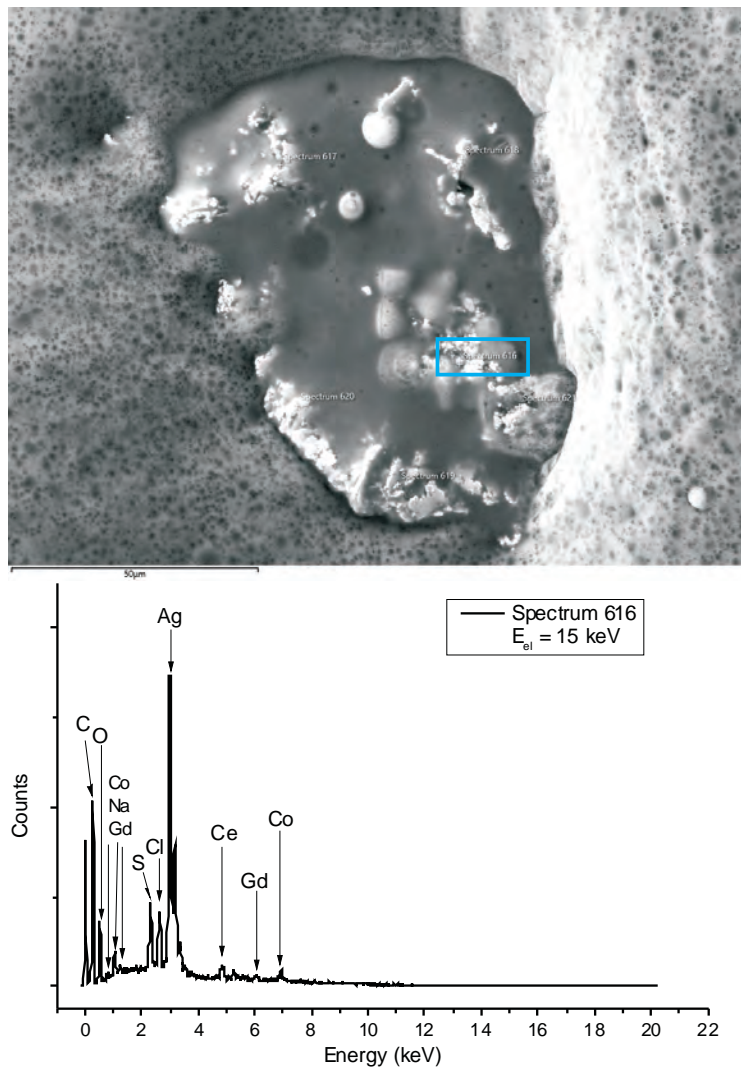
Figure 4 shows a SEM image of a contamination found in this sample. An EDX point spectrum taken at site 616 (c.f. Fig 4) reveals the presence of silver (Ag) as well as traces of S, Co, Ce and Gd localized in this contamination. The other point scans taken yield in similar results. The surrounding material is the organic part of the "mRNA-vaccine" exposed to the electron radiation.

Figure 4: Top: SEM image of a contamination. Bottom: EDX point spectrum of site 616 (marked by a blue frame).

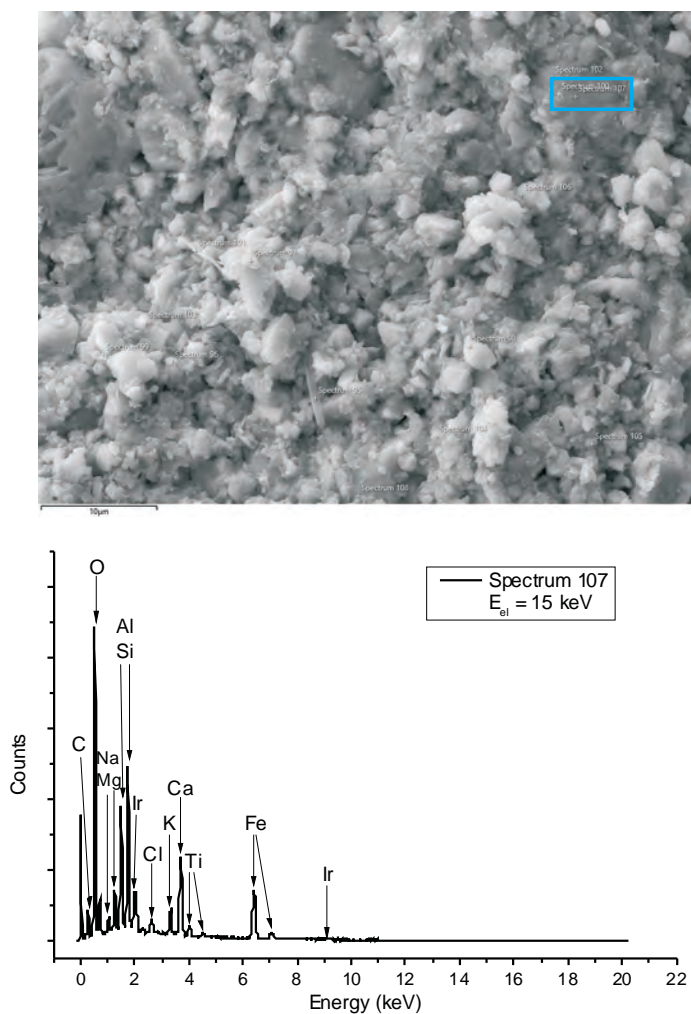
This sample was prepared at another lab opening the vial and then preparing the sample as described in section 2. Figure 5 shows a SEM image of a contamination found in this sample. An EDX point spectrum taken at site 616 (c.f. Fig 5) reveals the presence of Al and S, but also Ca, Fe, and Ti present in this contamination. The other point scans taken yield in similar results.

Figure 5: Top: SEM image of a contamination. Bottom: EDX point spectrum of site 107 (marked by a blue frame). Note that Ir does not belong to the sample probed by EDX due to the sample preparation described in 2.

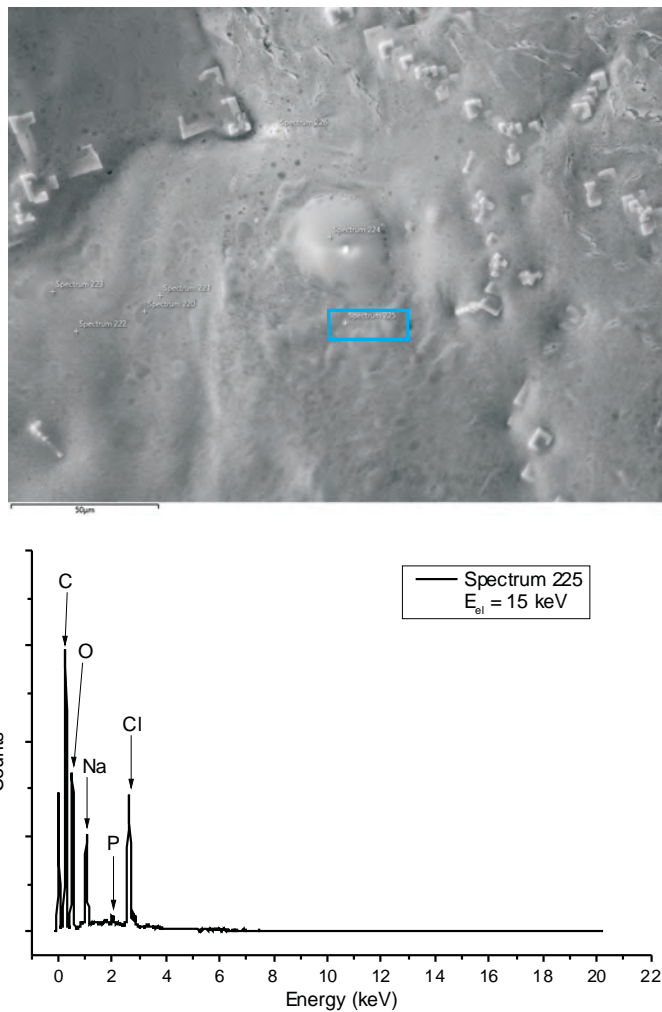
This sample was prepared via a syringe on a gold covered microscope slide as described in section 2. The EDX-spectrum shown in Fig.6 is typical for the dried Cormirnaty-”vaccine”, it consists mainly of Na und Cl (likely NaCl), phosphorus (P), which may stem from some of the lipids, and organic ingredients.

Figure 6: Top: SEM image of dried vaccine including contamination in the center. Bottom: EDX point spectrum of dried vaccine (site 225), marked by a blue frame.

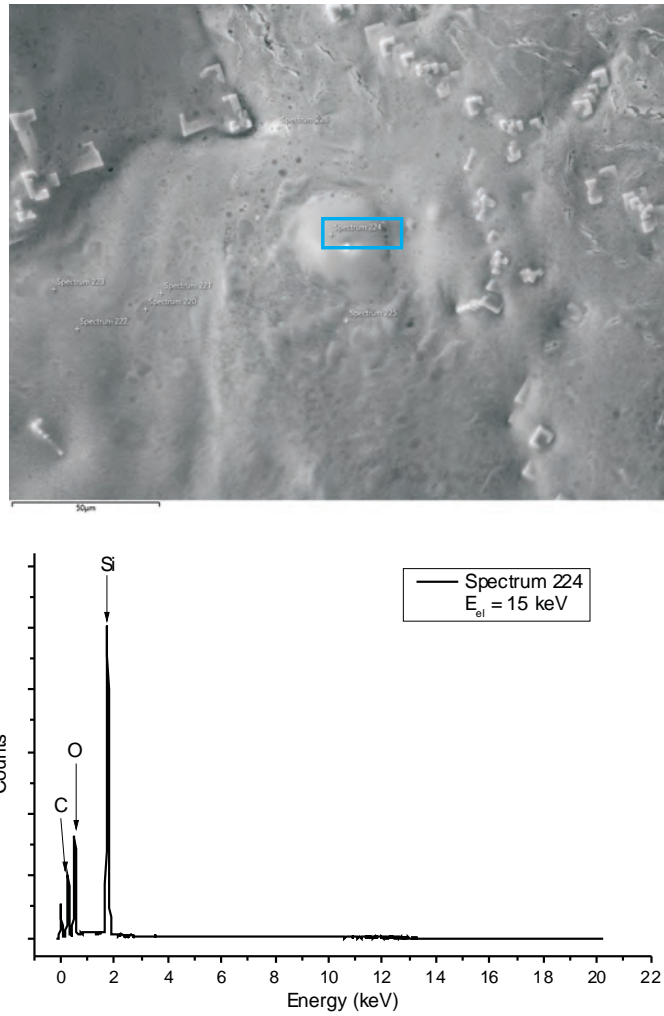
Figure 7 displays a SEM image of a contamination consisting of Si only as can be seen from the corresponding EDX-spectrum.

Figure 7: Top: SEM image of dried vaccine and a Si-contamination in the center. Bottom: EDX point spectrum of the Si (site 224), marked by a blue frame.

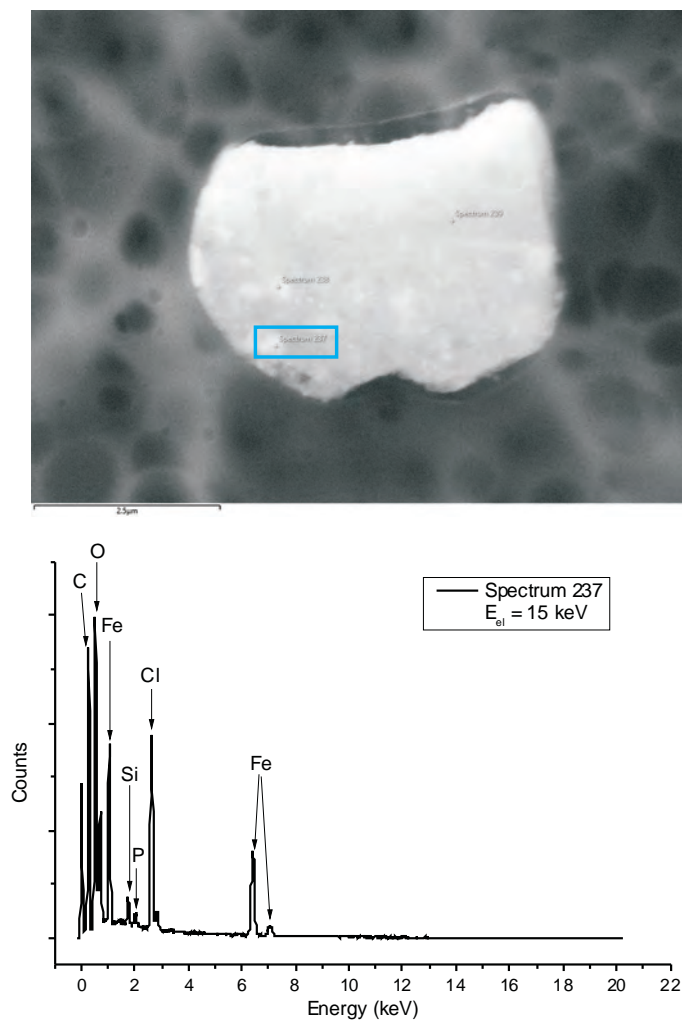
Figure 8 displays an Fe-containing particle found in this sample. The particles dimensions are $\approx 2.5\mu\text{m} \times 2.0\mu\text{m}$

Figure 8: Top: SEM image of a $2.5\mu\text{m}$ wide contamination. Bottom: EDX point spectrum of the Fe containing particle (site 237), marked by a blue frame.

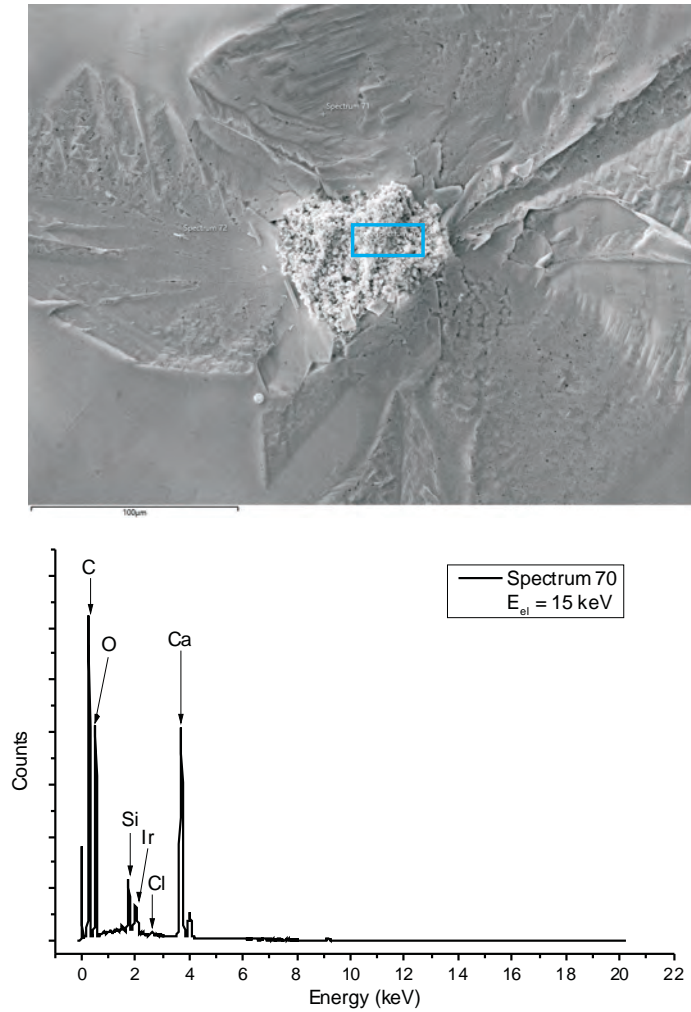
This sample was prepared at another lab opening the vial and then preparing the sample as described in section 2. Figure 9 shows a SEM image of a contamination consisting mainly of Ca, traces of Si are also present.

Figure 9: Top: SEM image of a contamination of $40\text{-}50\mu\text{m}$ size. Bottom: EDX point spectrum of this contamination (site 70), marked by a blue frame. Note that Ir does not belong to the sample probed by EDX due to the sample preparation described in 2.

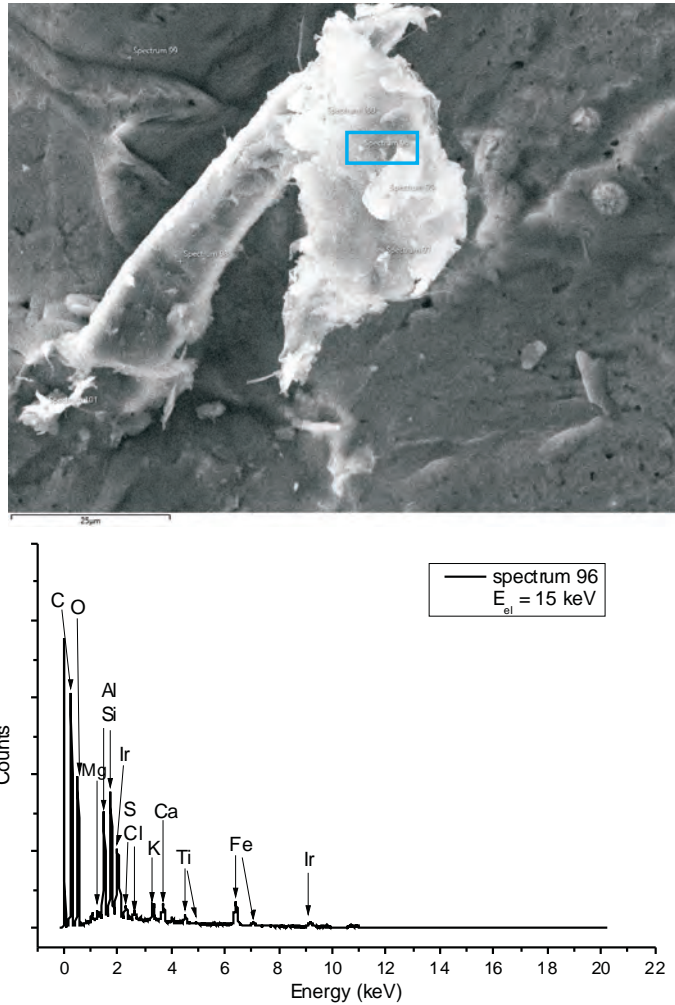
Figure 10 shows a SEM image of a contamination comprising a number of chemical elements. Besides Mg, Al, Si, S, K, and Ca also the 3d transition metals Ti and Fe are detected. The other point spectra recorded at this contamination yield to similar results in terms of the elements detected, with partly changing stoichiometry.

Figure 10: Top: SEM image of a contamination of 25-30 μm size. Bottom: EDX point spectrum of this contamination (site 96), marked by a blue frame. Note that Ir does not belong to the sample probed by EDX due to the sample preparation described in 2.

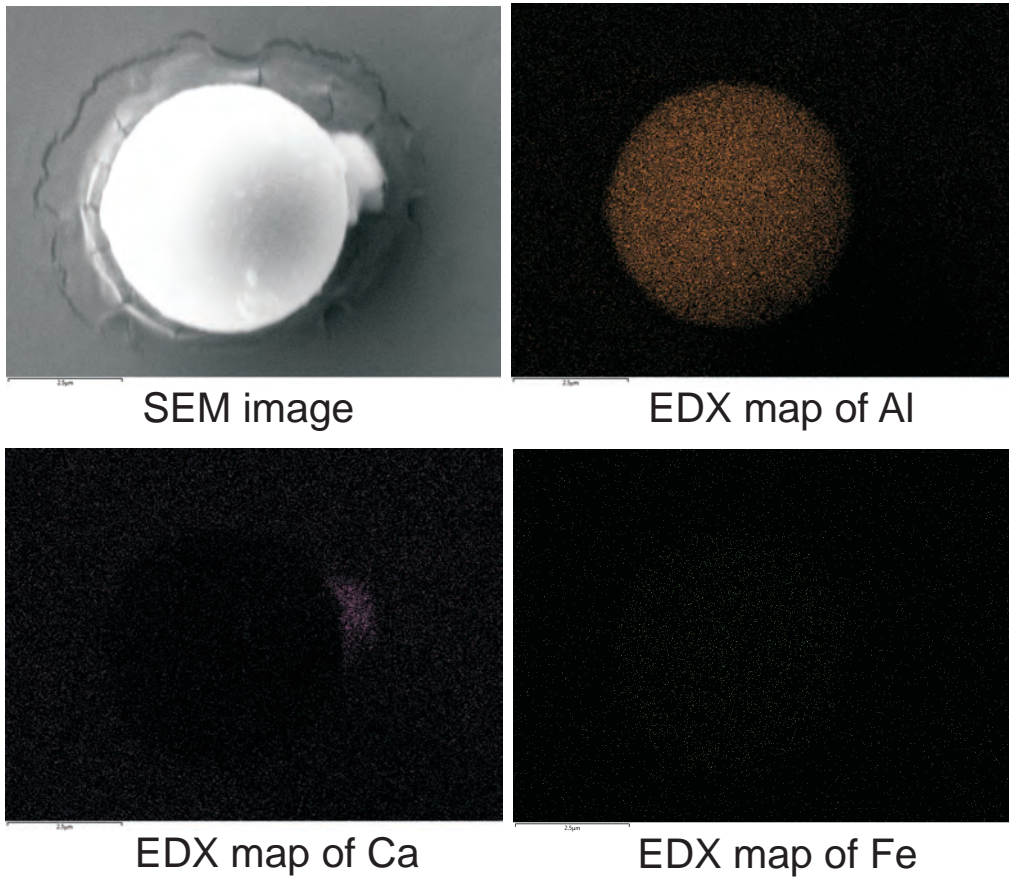
Figure 11 (top left) shows a SEM image of a particle in the form of a sphere. This sphere consists mainly of Al, some Ca and traces of Fe are also present as can be seen from the element specific spatial EDX mapping results.

Figure 11: Top left: SEM image of a sphere of $3\mu\text{m}$ diameter. Top right: Element specific EDX mapping of Al. Bottom: element specific EDX mappings of Ca and Fe.

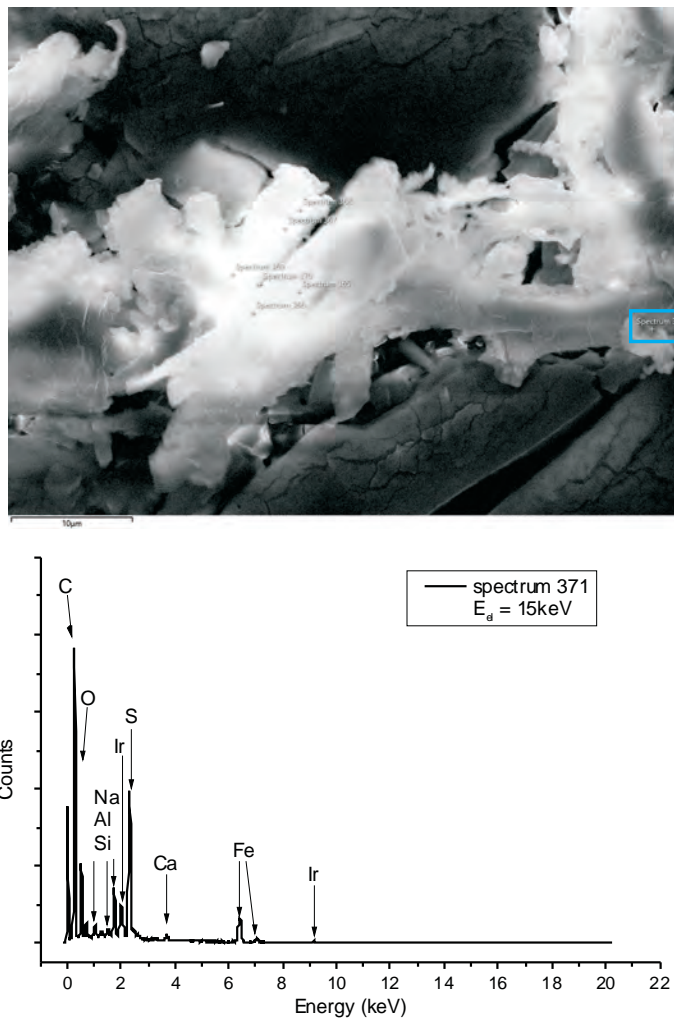
This sample was prepared at another lab opening the vial and then preparing the sample as described in section 2. Figure 12 shows a SEM image of a contamination consisting mainly of S, Some Fe is also present. Furthermore, traces of Na, Al, Si, and Ca are detected. The other point scans taken yield in similar results, with partly changing stoichiometry.

Figure 12: Top: SEM image of a contamination of $40\mu\text{m} \times 10\mu\text{m}$ size. Bottom: EDX point spectrum of this contamination (site 371), marked by a blue frame. Note that Ir does not belong to the sample probed by EDX due to the sample preparation described in 2.

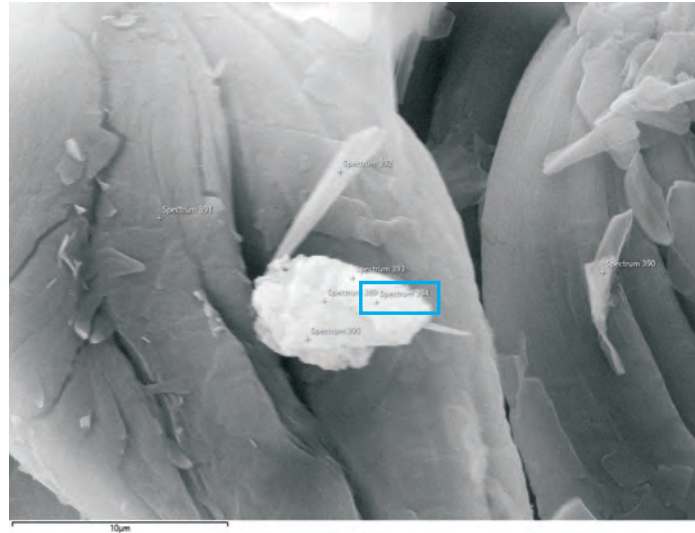
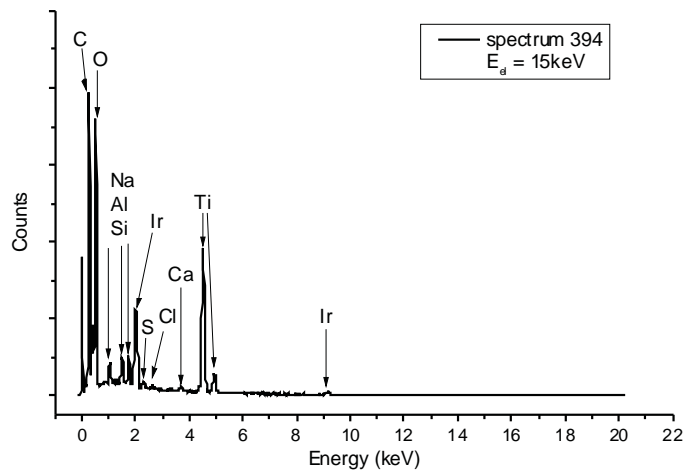
Figure 13 shows a SEM image of a contamination comprising significant amounts of Ti, traces of Na, Al, Si, S, and Ca are also detected.

Figure 13: Top: SEM image of a particle of $5\mu\text{m}$ size. Bottom: EDX point spectrum of this particle (site 394), marked by a blue frame. Note that Ir does not belong to the sample probed by EDX due to the sample preparation described in 2.

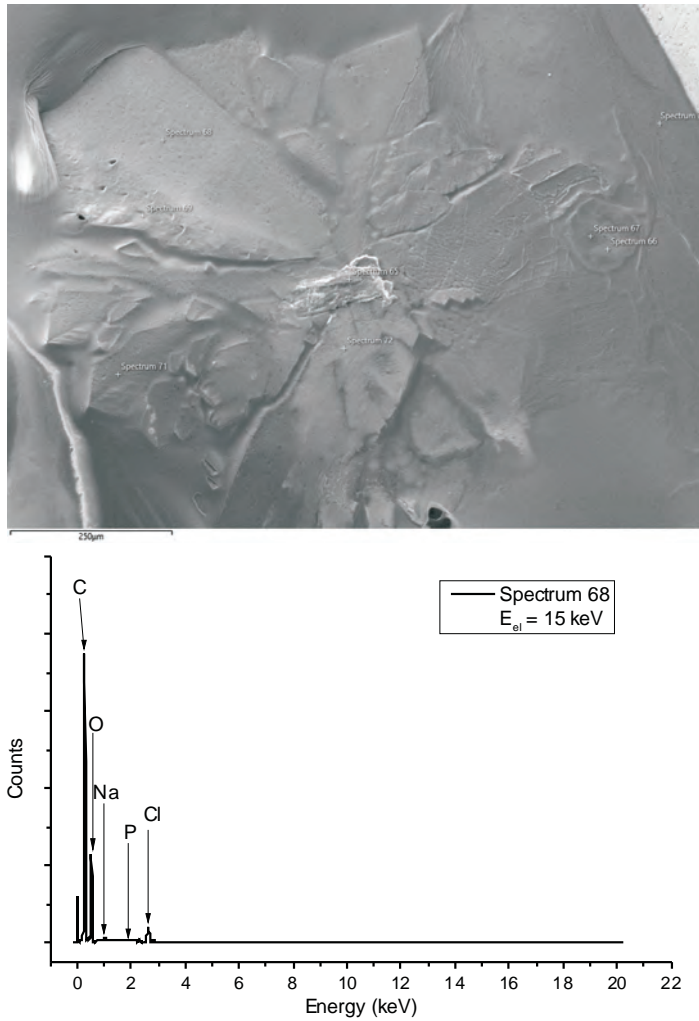
This sample was prepared via a syringe on a gold covered microscope slide as described in section 2. The EDX-spectrum shown in Fig.14 is typical for the dried Spikevax-” vaccine”, it consists of Na und Cl (likely NaCl), traces of P, which may stem from some of the lipids, and manly, organic ingredients.

Figure 14: Top: SEM image of dried vaccine. Bottom: EDX point spectrum of dried vaccine (site 68), marked by a blue frame.

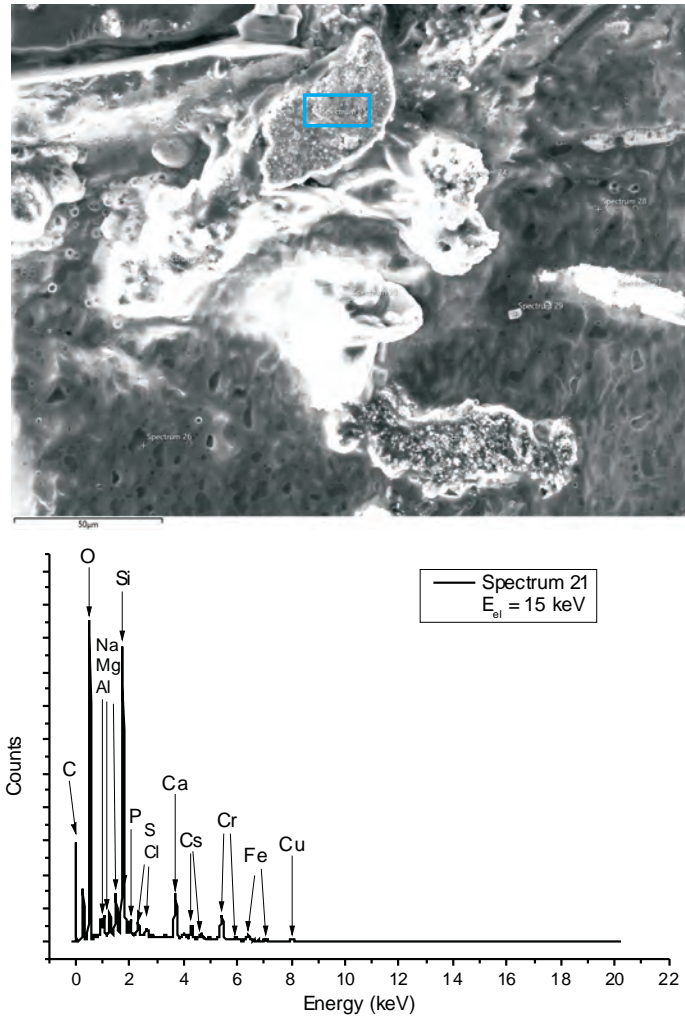
This sample was prepared via a syringe on a gold covered microscope slide as described in section 2. Figure 15 shows a SEM image of a contamination comprising significant amounts of Si. Besides traces of Na, Mg, Al, P, S, Cl, and Ca also the metals Cs, Cr, Fe, and copper (Cu) are detected.

Figure 15: Top: SEM image of a particle of 50 μm size. Bottom: EDX point spectrum of this particle (site 21), marked by a blue frame.

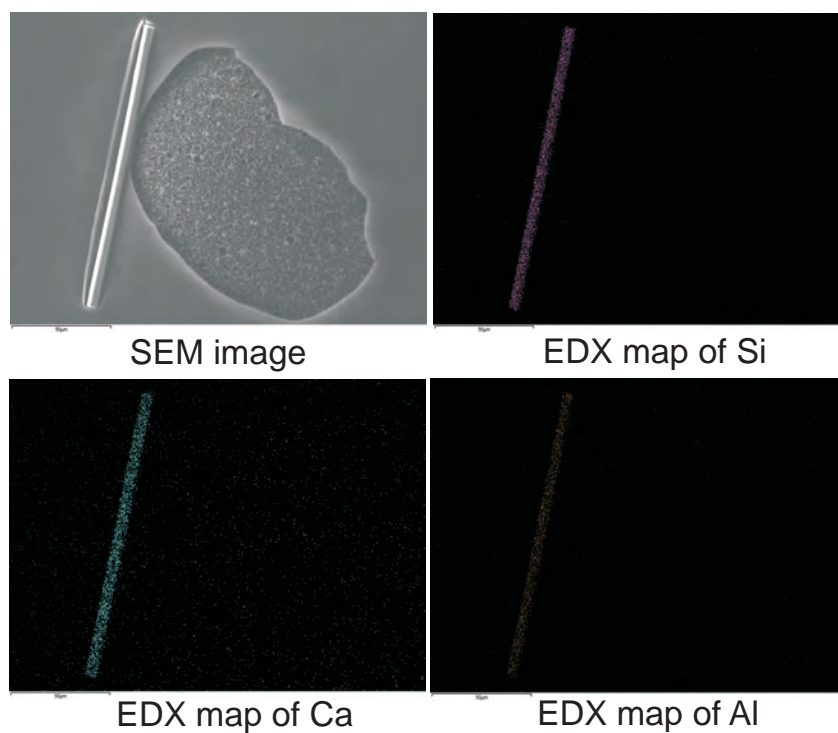
This sample was prepared via a syringe on a gold covered microscope slide as described in section 2. Figure 16 (top left) shows a SEM image of a rod like contamination. This rod like structure consists mainly of Si, some Ca and Al are also present as can be seen from the element specific spatial EDX mapping results.

Figure 16: Top left: SEM image of a rod like structure of $20\mu\text{m}$ length. Top right: Element specific EDX mapping of Si. Bottom: element specific EDX mappings of Ca and Al.

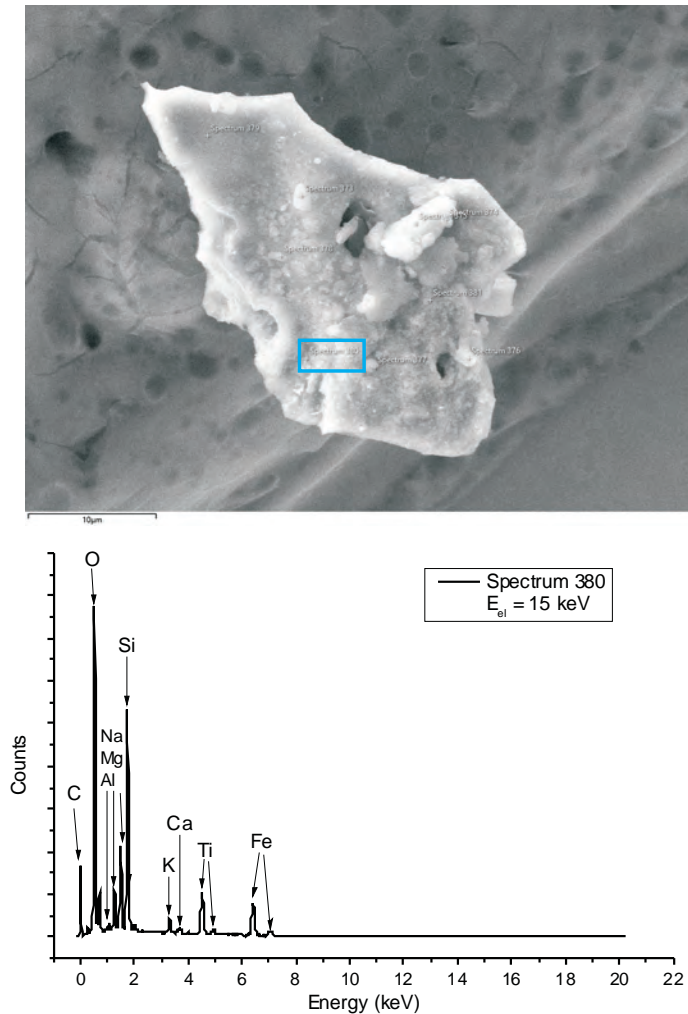
This sample was prepared from a vial of the same lot but at another lab opening the vial and then preparing the sample as described in section 2. Figure 17 shows a SEM image of a contamination comprising significant amounts of Si, Ti, and Fe. Traces of Na, Mg, Al, K, and Ca are also detected.

Figure 17: Top: SEM image of a particle of 15-20 μm size. Bottom: EDX point spectrum of this particle (site 380), marked by a blue frame. Note that Ir does not belong to the sample probed by EDX due to the sample preparation described in 2.

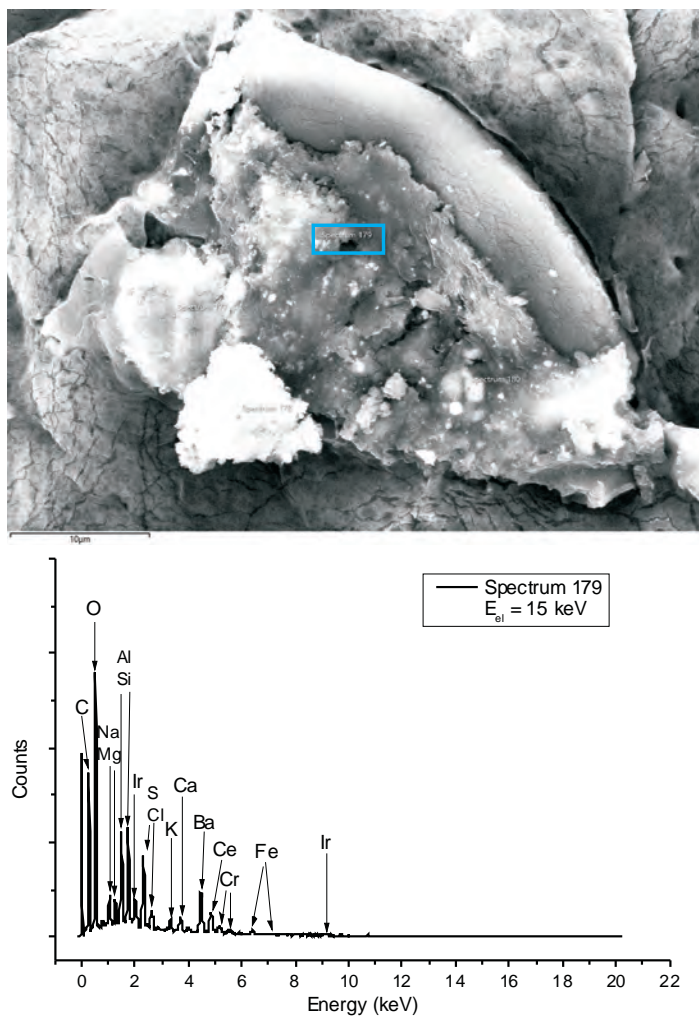
This sample was prepared from a vial of the same lot but at another lab opening the vial and then preparing the sample as described in section 2. Figure 18 shows a SEM image of a contamination comprising significant amounts of Al, Si, S, and Ba. Traces of Na, Mg, S, Cl, K, Ca, Ce, Cr, and Fe are also detected.

Figure 18: Top: SEM image of a contamination of 20-30 μm size. Bottom: EDX point spectrum of this particle (site 179), marked by a blue frame. Note that Ir does not belong to the sample probed by EDX due to the sample preparation described in 2.
